CEBAF-PR-95-060

PROCUREMENT AND COMMISSIONING OF THE CHL REFRIGERATOR AT CEBAF*

Continuous Electron Beam Accelerator Facility
12000 Jefferson Avenue
Newport News, VA 23606-1909 USA

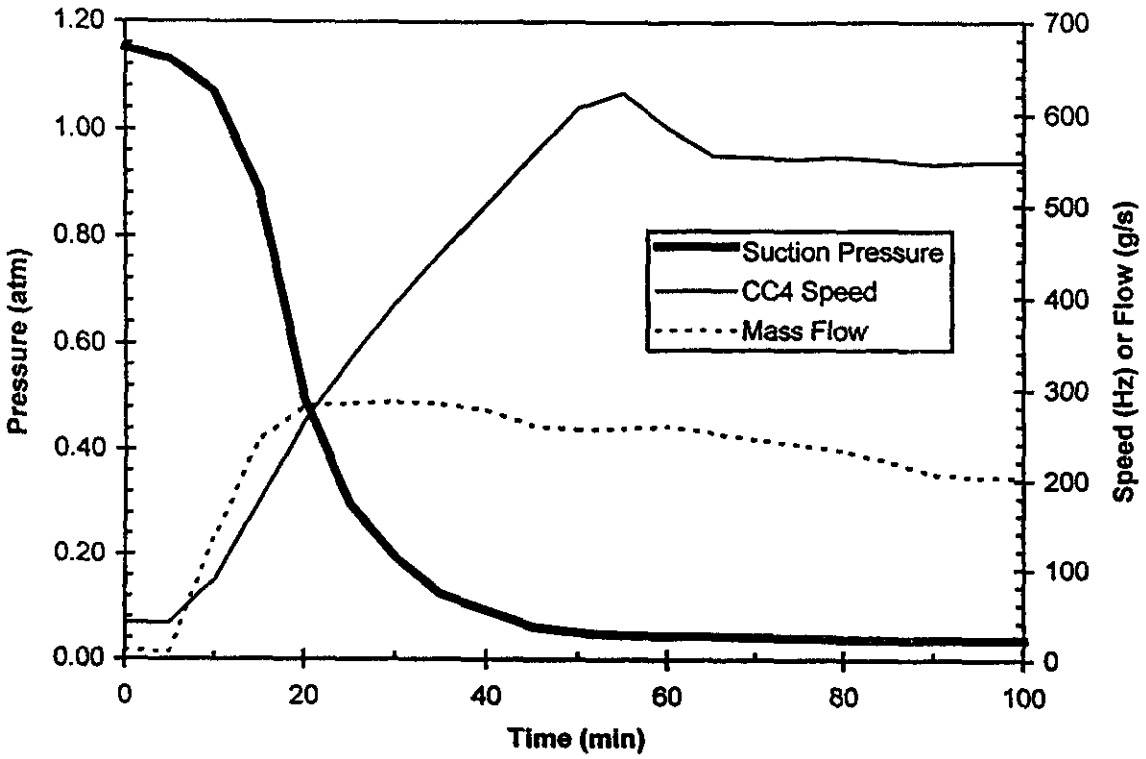
The initial pumpdowns of the linacs, after being at 4.5K for long periods of time, have required about eight hours to complete. The normal pumpdowns experienced, where a restart is possible within three to four hours, require about 2.5 hours. The pumpdown procedure has been modified several times and the latest procedure is to delay adding heat until a pressure of 40 mb has been reached. Additional information on the pumpdown is presented in reference 4. A typical pumpdown curve is presented in Figure 2.

Figure 2. Repair and pumpdown cycle.

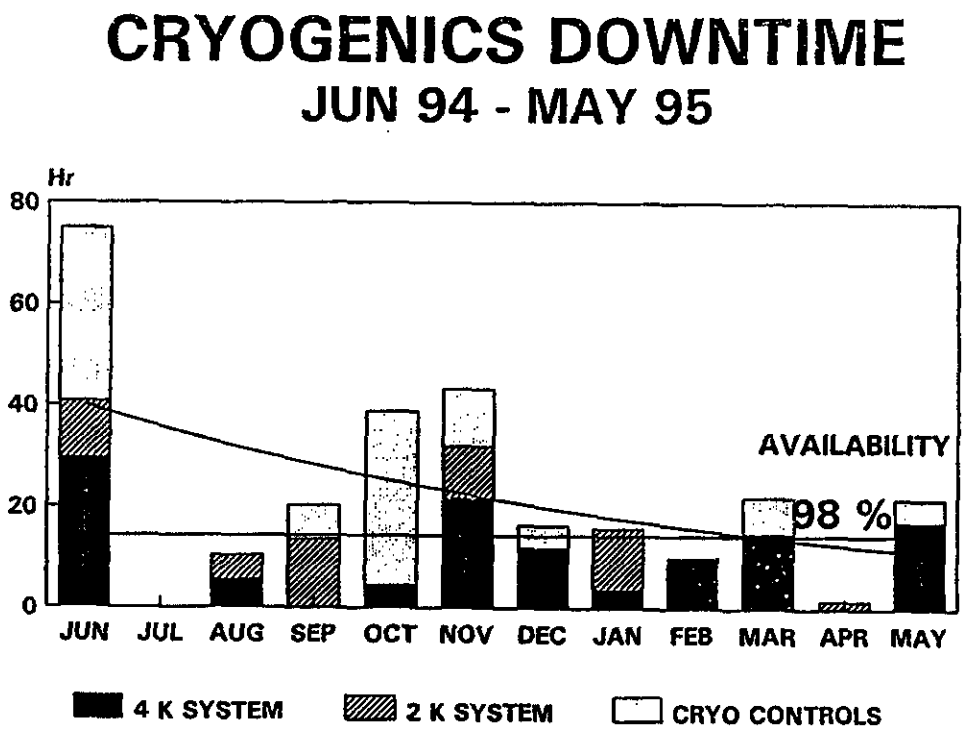
Cryogenic availability for the previous year has averaged 96.9% and 98.0% for the last six months; the downtime and its causes are shown in figure 3. The causes are split between the 4K system (1.4%), and the 2K system (0.6%), and the cryogenic controls (1.2%). The cryogenic controls category includes cryogenic software and hardware, as well as linac cryogenic instrumentation for the cavities. Not included in the downtime is another 0.8% of nonavailability charged to other sub-systems such as utilities; these included site power, city water, end station errors, and MCC problems.

The primary 4K system downtime was caused by contamination tripping the 25K and 15K turbines; the turbine trip in turn causes a temperature transient, which would trip the cold compressors. Other causes included the warm screw compressor trips and some control valves.

Only one of the 2K system downtimes was associated with the cold compressor hardware; with a valiant 14 hour all-night effort, it was possible to get the magnetic bearing electronics operational again. Six downtimes were due to excursions of the cold compressors out of their stable operating regions, and were not traceable to any equipment failures.

The unreasonably large cryo control downtime was due to three root causes: A) a failure of a supervisory LAN connection and/or board, B) intermittent failures of the linac serial highways which transmit load liquid level information, and C) overloading of memory allocations due to adding the third refrigeration system, ESR, to the network. The first was fixed by replacing several boards and reworking all the terminations, the second problem still remains, and the third has been partially fixed.

Figure 3. Cryogenic downtime (June 1994 - May 1995)
